Regina Public Library Building Assessment

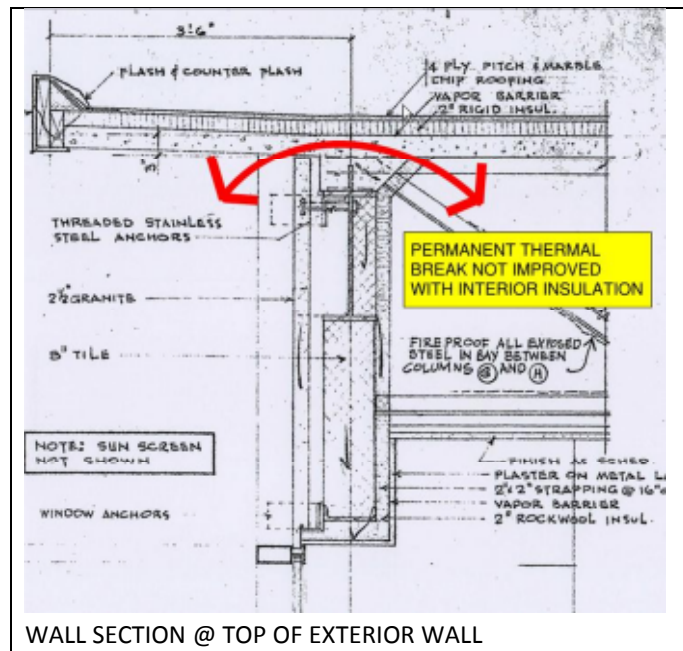
The sketch at right shows the thermal break that will remain if the exterior wall remains in place and additional insulation is provided at the inside of the wall only. The increased insulation on the inside of the wall will increase the potential for frost and condensation to form at the thermal break. i.e. on the inside surfaces of the thermal break.

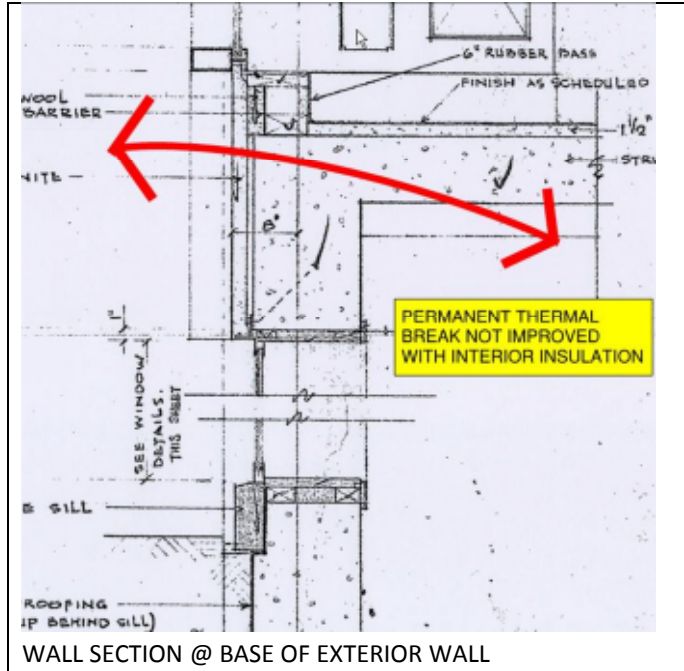
Another problem with the interior insulation renovation is the lack of a high quality air barrier. Interior insulation can only add a vapour barrier on the inside of the new insulation. A cavity wall system as described below is technically a far superior wall construction that incorporates a vapour barrier and an air barrier into one element that allows proper venting of the insulation space.

The above noted insulation conditions can only be improved with the implementation of a cavity type wall on the exterior walls. Cavity walls are comprised of an exterior finish, a vented air space, insulation, air barrier and interior wall structure. The existing wall construction cannot be retrofitted to a cavity wall without a complete dismantling of the wall and reconstructing a new wall.

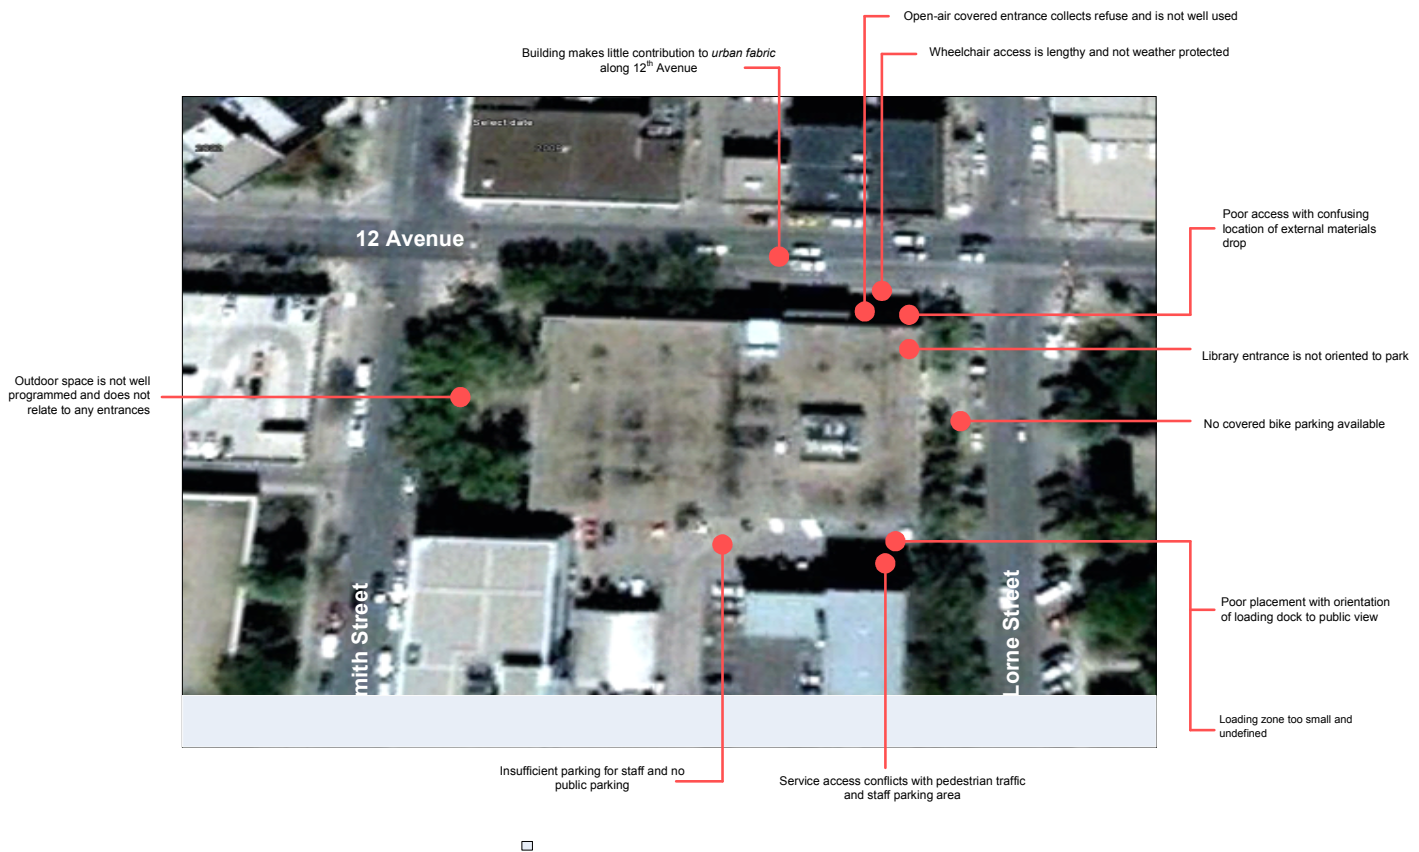
The site usage and organization of the existing RPL is very weak and was poorly considered in the original design. The diagram below outlines some readily apparent shortcomings.
