Regina Public Library Building Assessment

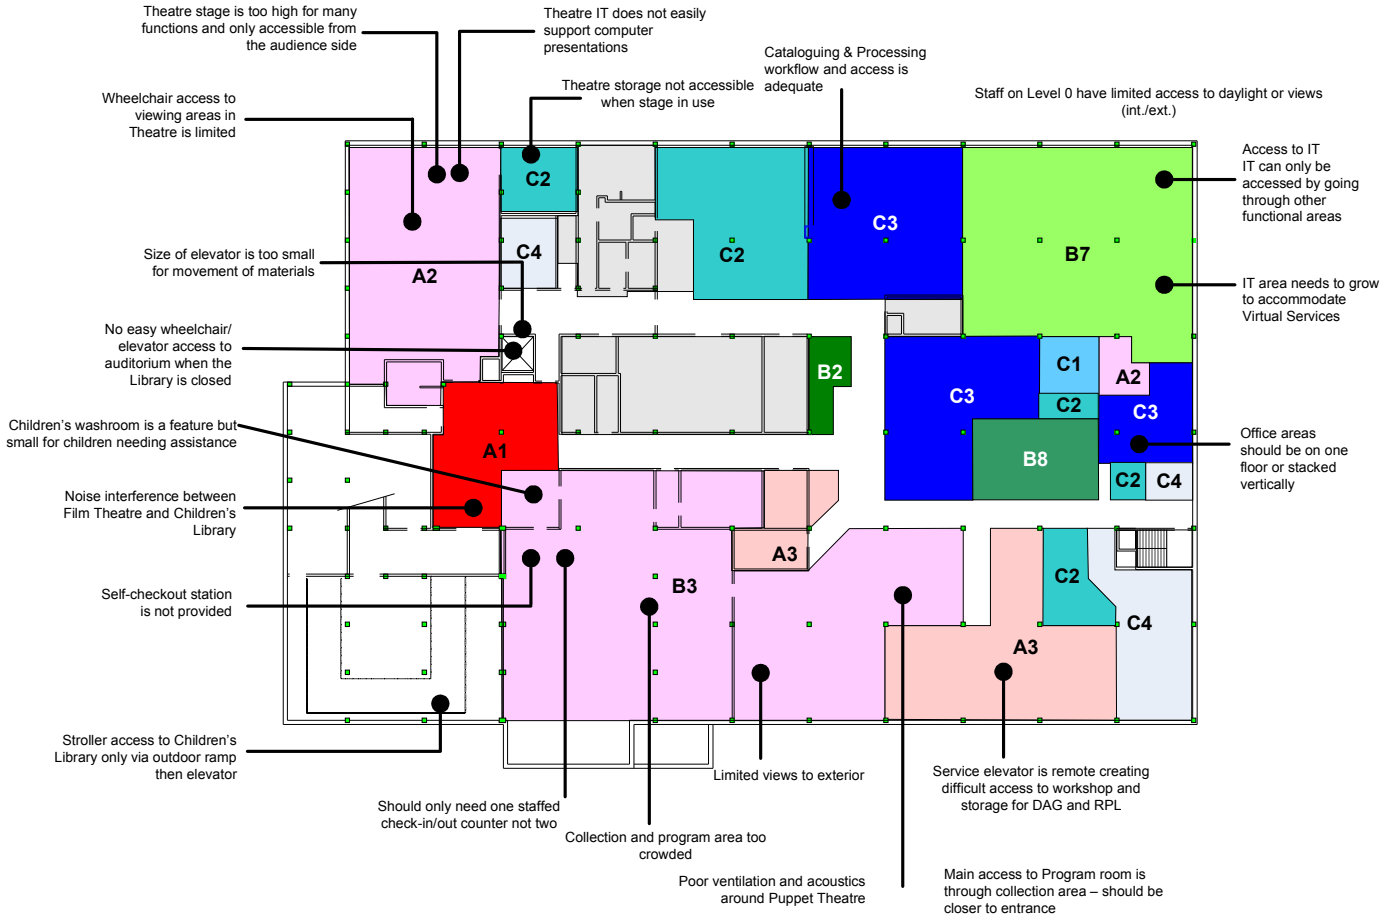
Floor Level 0

The functional analysis indicates the Library Building suffers functionally, primarily due to overall building layout and the vertical circulation systems. For instance, a single elevator is used for the public and staff and as a service elevator. It is also used as a through-corridor, linking the loading dock with the main public floor. The elevator is located within the Library’s security zone, yet must serve functions that operate outside of the Library’s hours of operation. Many other functional issues exist necessitating a complete revision of the building plan to perform as a modern library. The analysis does not presume any addition vertically or horizontally.
